**SCREENING SITE INSPECTION REPORT
FOR
HALLIE TOWN LANDFILL
CHIPPEWA FALLS, WISCONSIN
U.S. EPA ID: WID981095920
SS ID: NONE
TDD: F05-8905-015
PAN: FWI0149SA**

APRIL 25, 1990

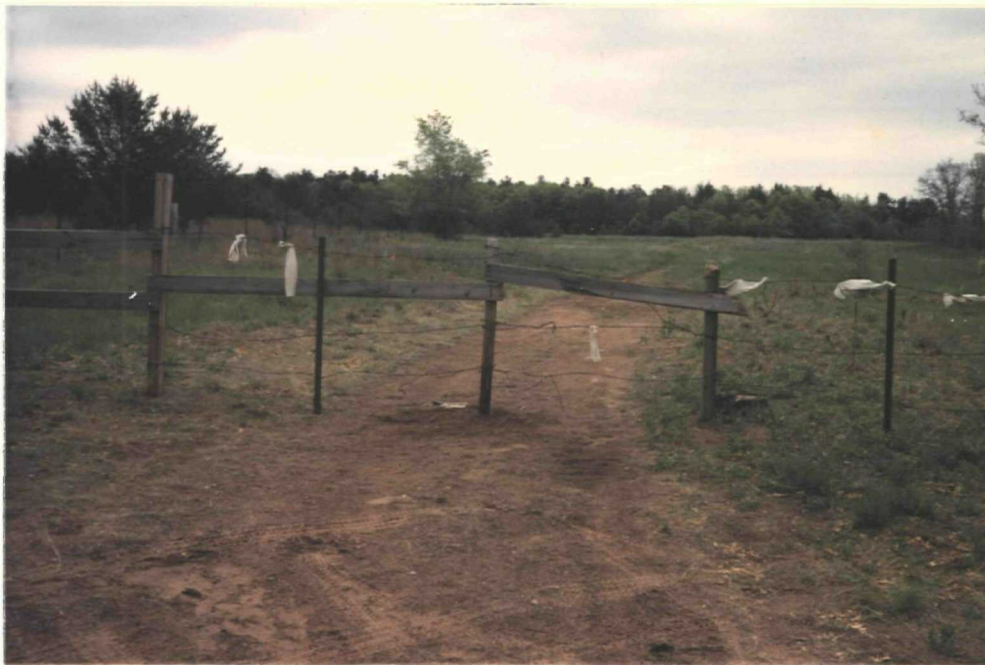
DESCRIPTION: Entrance and access road to the
landfill.

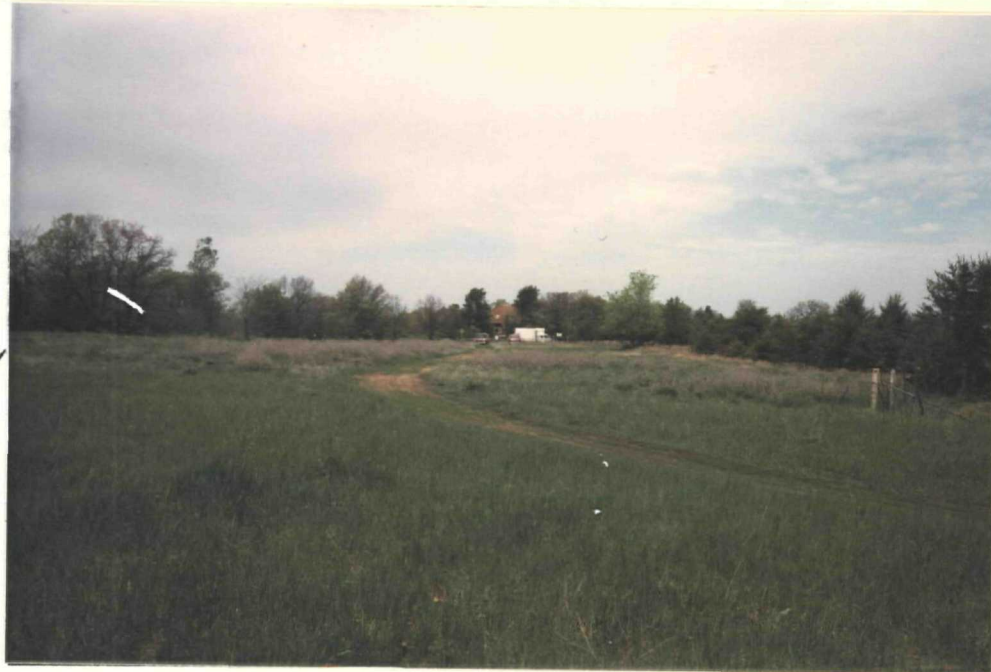
DESCRIPTION: Northern portion of landfill looking toward
the entrance gate.

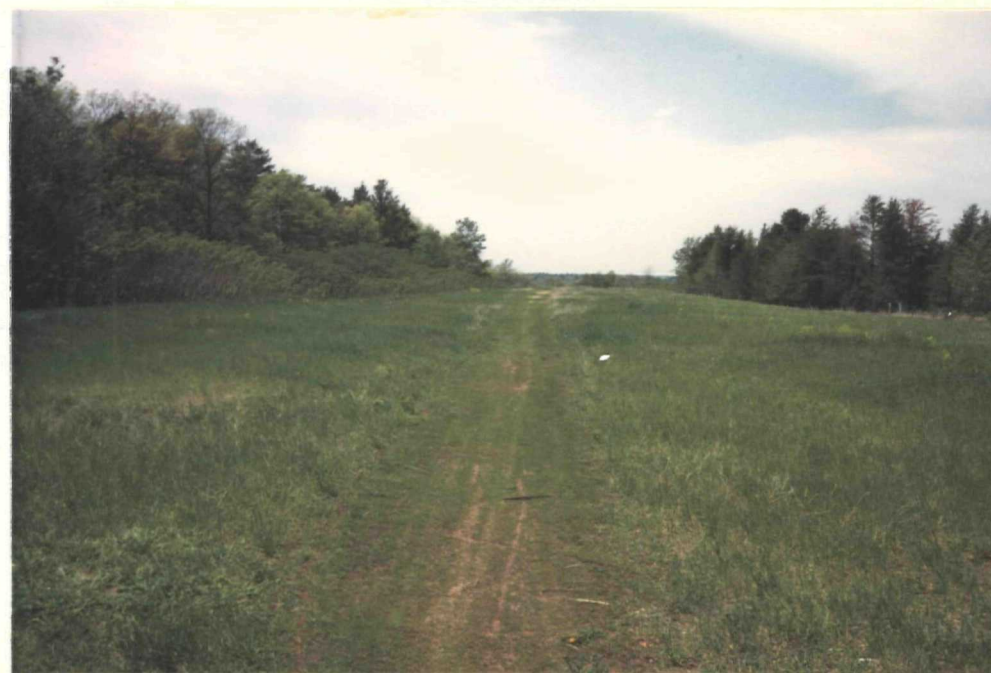
DESCRIPTION: Western end of the landfill.

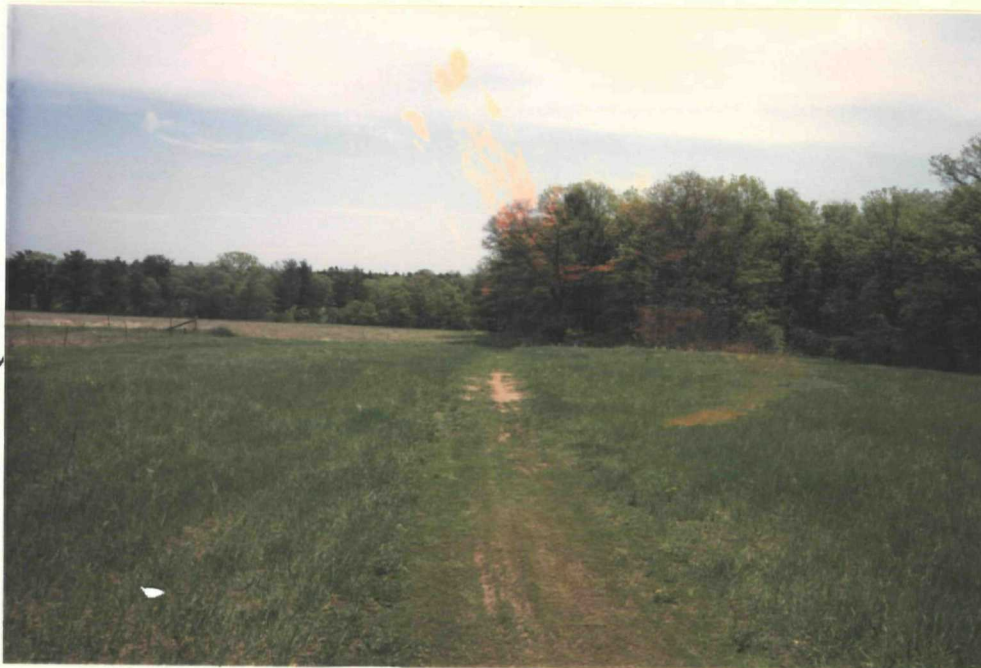
DESCRIPTION: Eastern end of land fill.DATE: 5/23/89TIME: 1230DIRECTION OF
PHOTOGRAPH:SEWEATHER
CONDITIONS:Mostly SunnyMid 70's

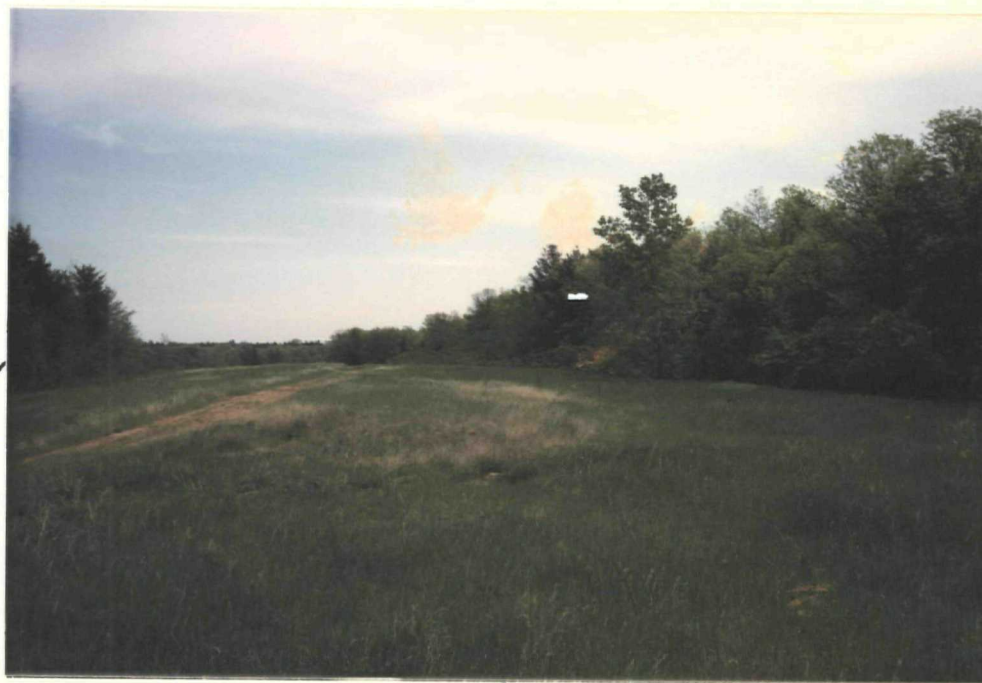
DESCRIPTION: Southeast corner of landfill.

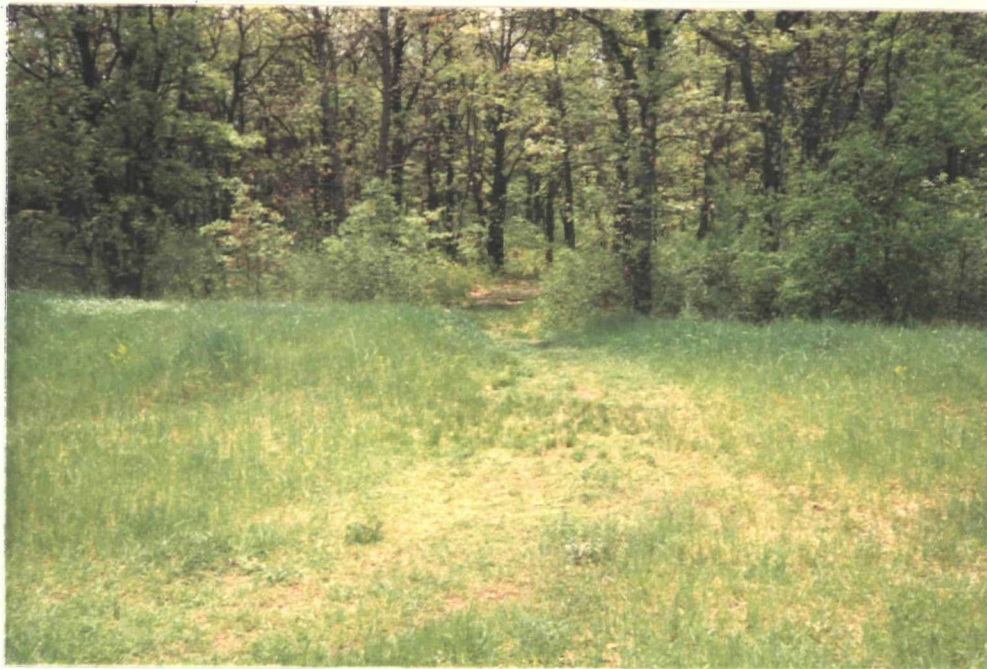
DESCRIPTION: Trail entering the site from the south.

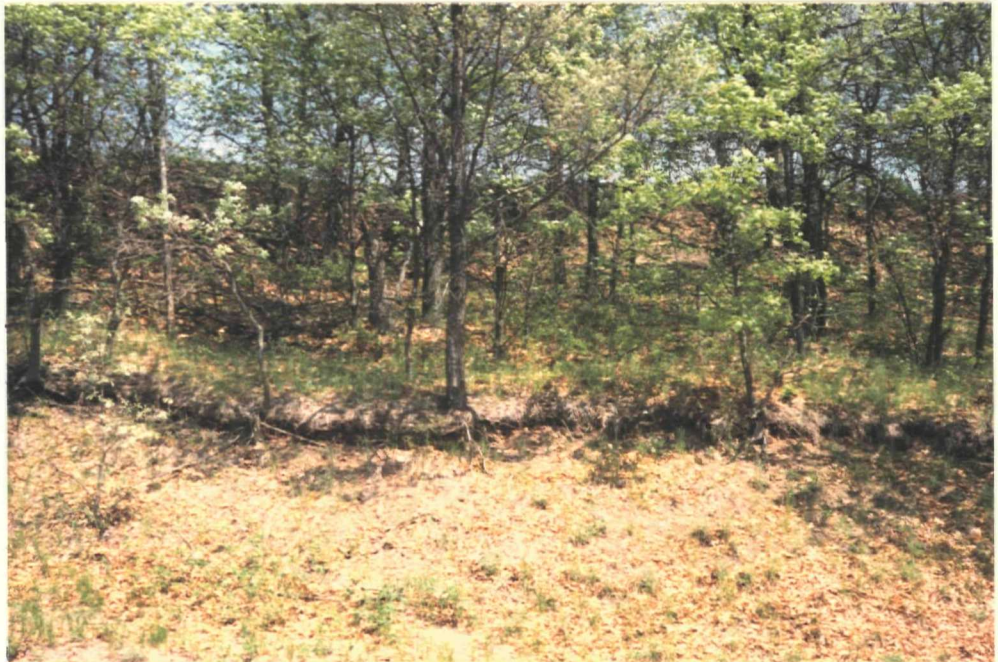
DESCRIPTION: West side of the site photographed
from Shaffer Rd.DATE: 5/23/89TIME: 1420DIRECTION OF
PHOTOGRAPH:
EWEATHER
CONDITIONS:
Mostly SunnyMid 70'sPHOTOGRAPHED BY:
T. NehrKornSAMPLE ID
(if applicable):

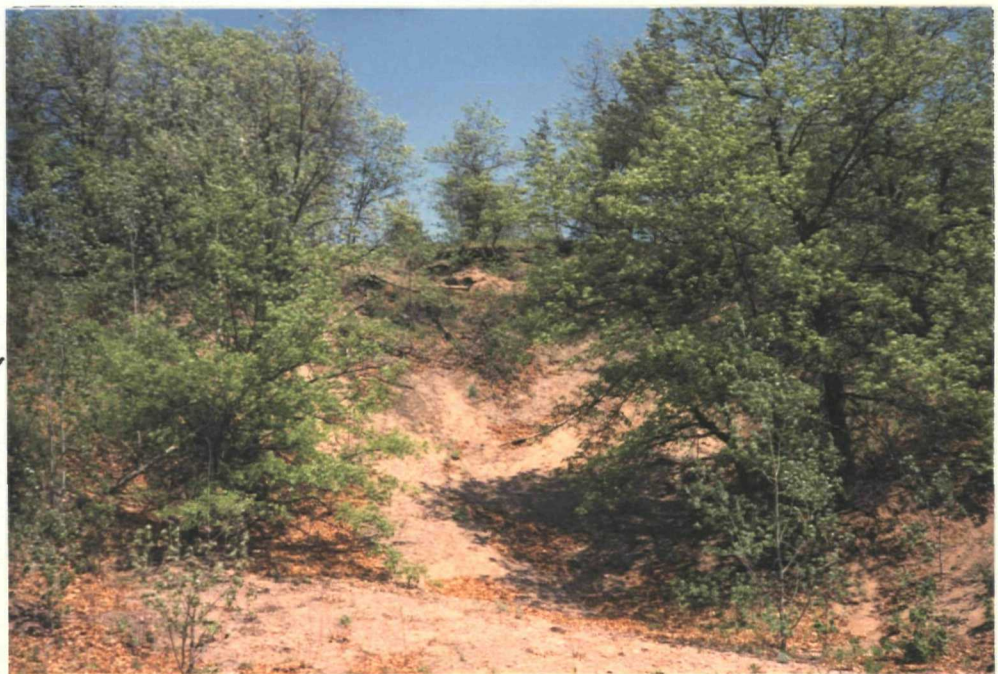
DESCRIPTION: Southwest Corner of the site photographed
from Shaffer Rd.

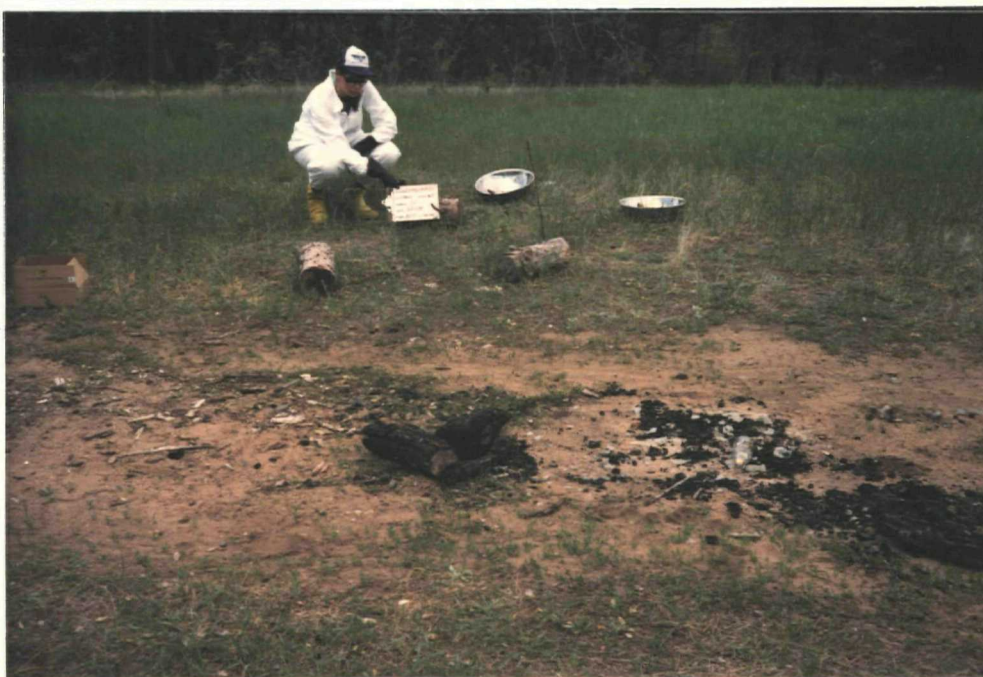
DESCRIPTION: Close up View of soil sample SI collected
near an old campfire.DATE: 5/23/89TIME: 1245DIRECTION OF
PHOTOGRAPH:NWEATHER
CONDITIONS:Mostly SunnyMid 70's

DESCRIPTION: Perspective view of soil sample SI.

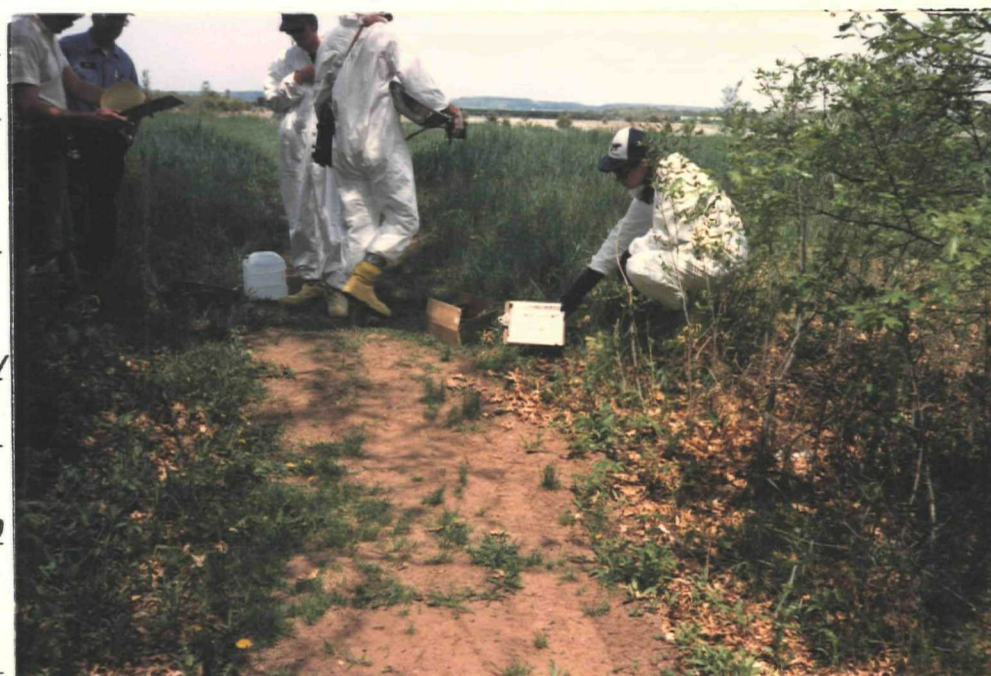
DESCRIPTION: Close up view of soil sample S2
collected near dirt trail on south side of
the site.DATE: 5/23/89TIME: 1255DIRECTION OF
PHOTOGRAPH:NWEATHER
CONDITIONS:Mostly SunnyMid 70's

DESCRIPTION: Perspective view of soil sample S2.

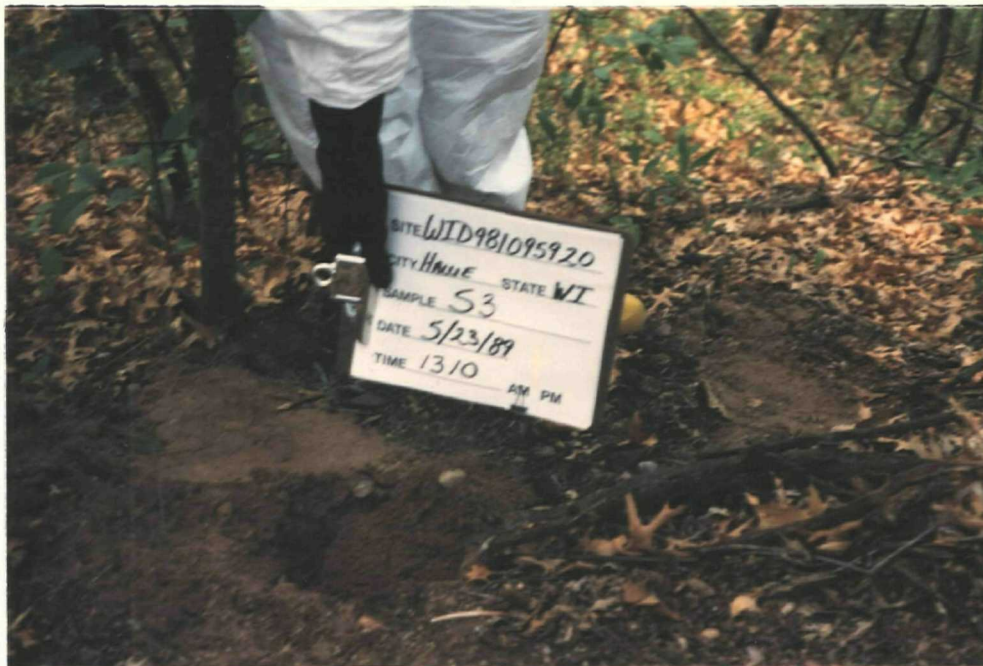
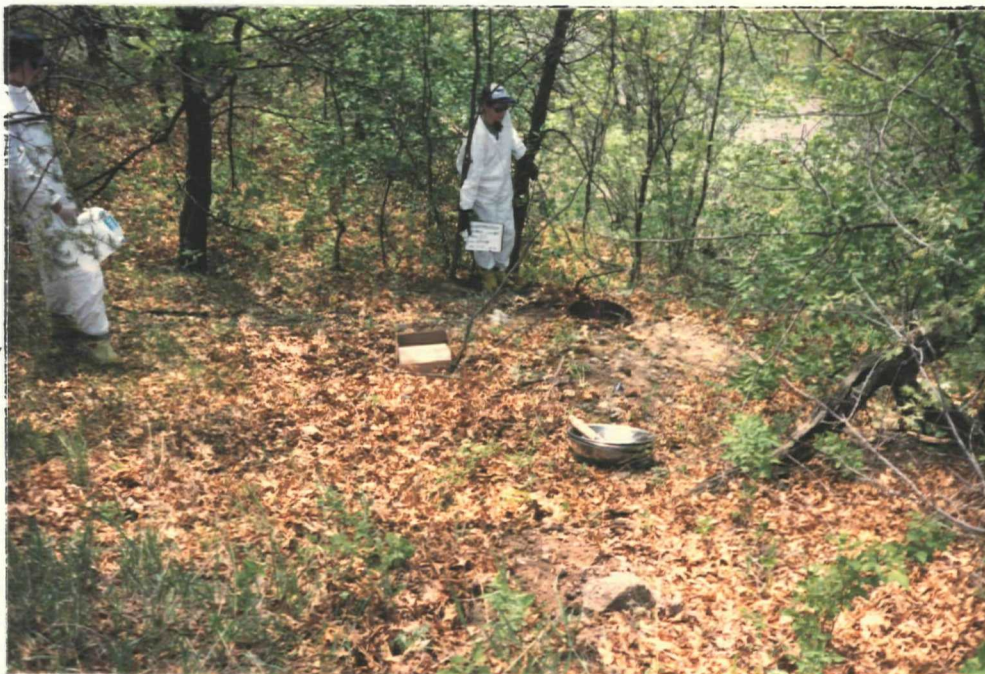
DESCRIPTION: Close up view of soil sample S3 collected from an area at the bottom of a gully on the south west corner.DATE: 5/23/89TIME: 1310DIRECTION OF
PHOTOGRAPH:WWEATHER
CONDITIONS:Mostly SunnyMid 70's

DESCRIPTION: Perspective view of soil sample S3.

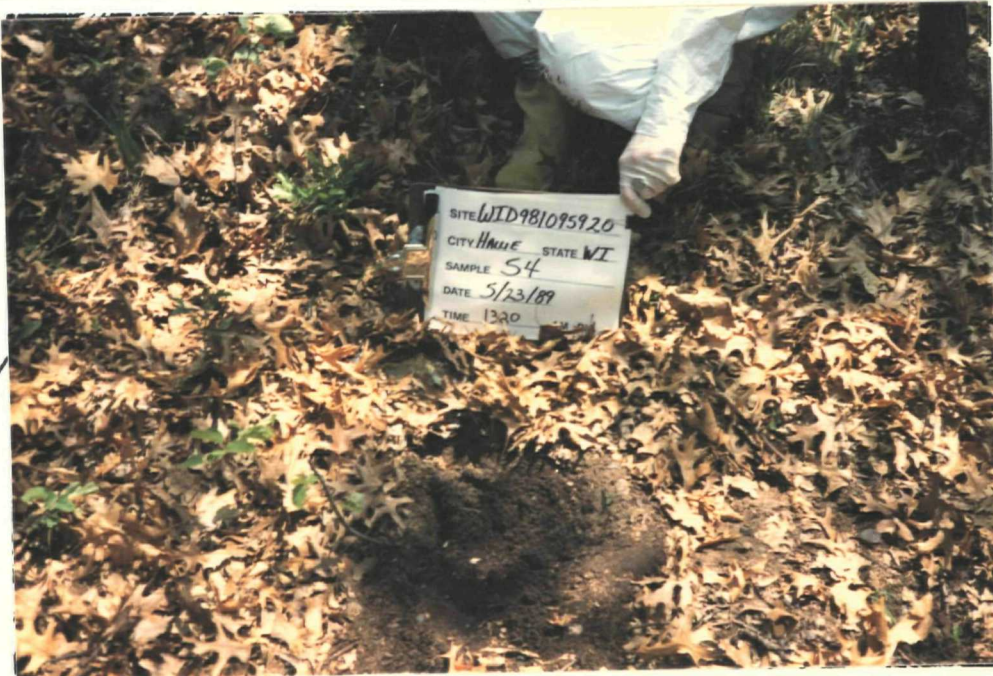
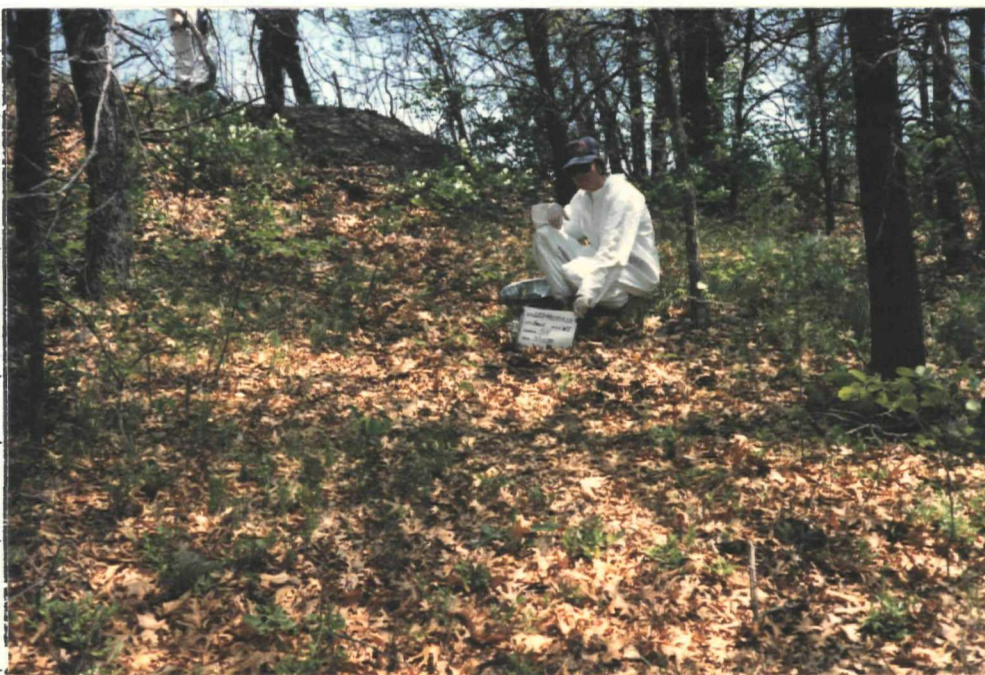
DESCRIPTION: Close up view of soil sample S4 collected from an eroded area on the west side of the site.DATE: 5/23/89TIME: 1320DIRECTION OF
PHOTOGRAPH:E

DESCRIPTION: Perspective view of soil sample S4.

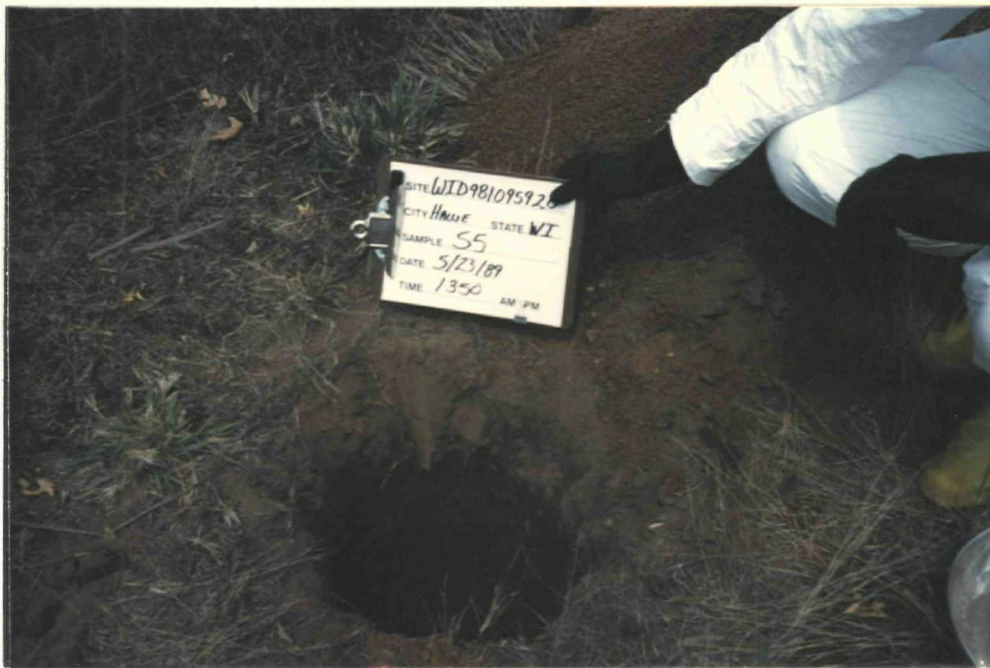
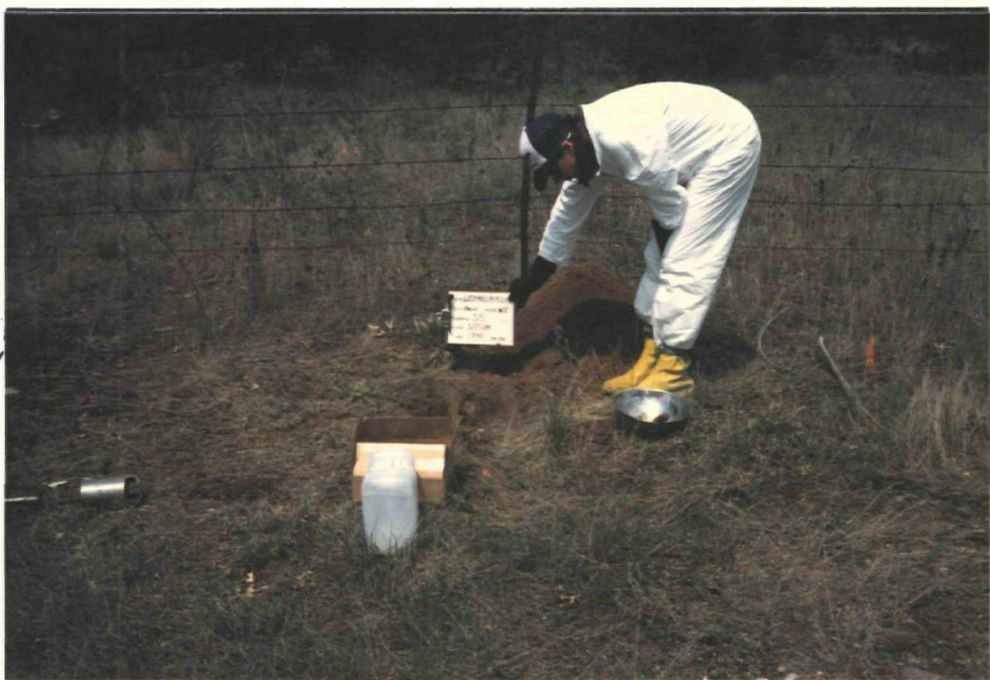
DESCRIPTION: Close up view of soil sample S5 collected
at depth along the fence line along the north side
of the site.DATE: 5/23/89TIME: 1350DIRECTION OF
PHOTOGRAPH:NWEATHER
CONDITIONS:Mostly SunnyMid 70's

DESCRIPTION: Perspective view of soil sample S5.

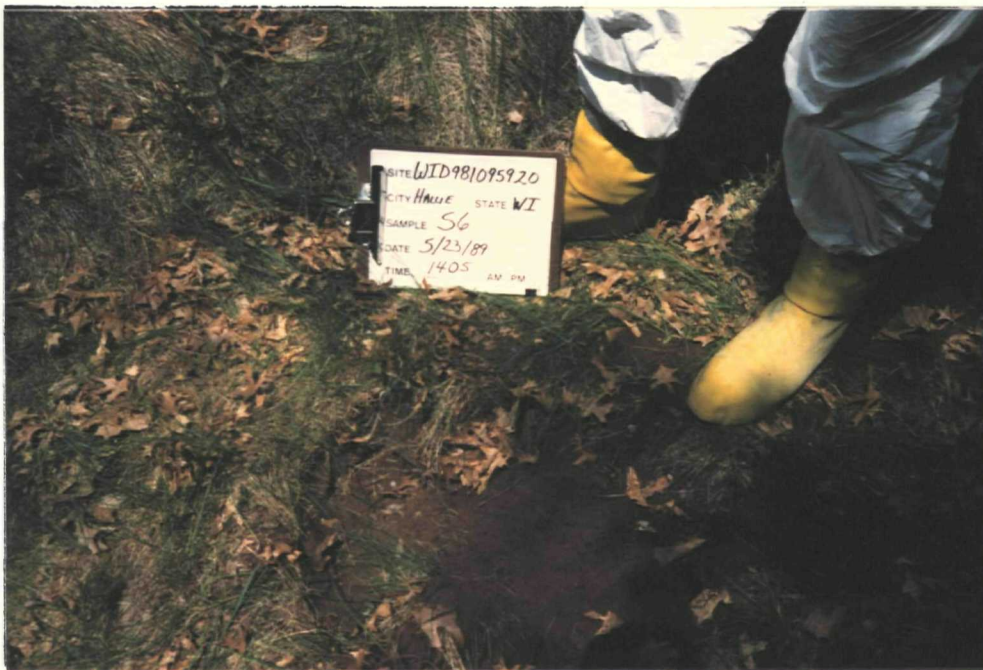
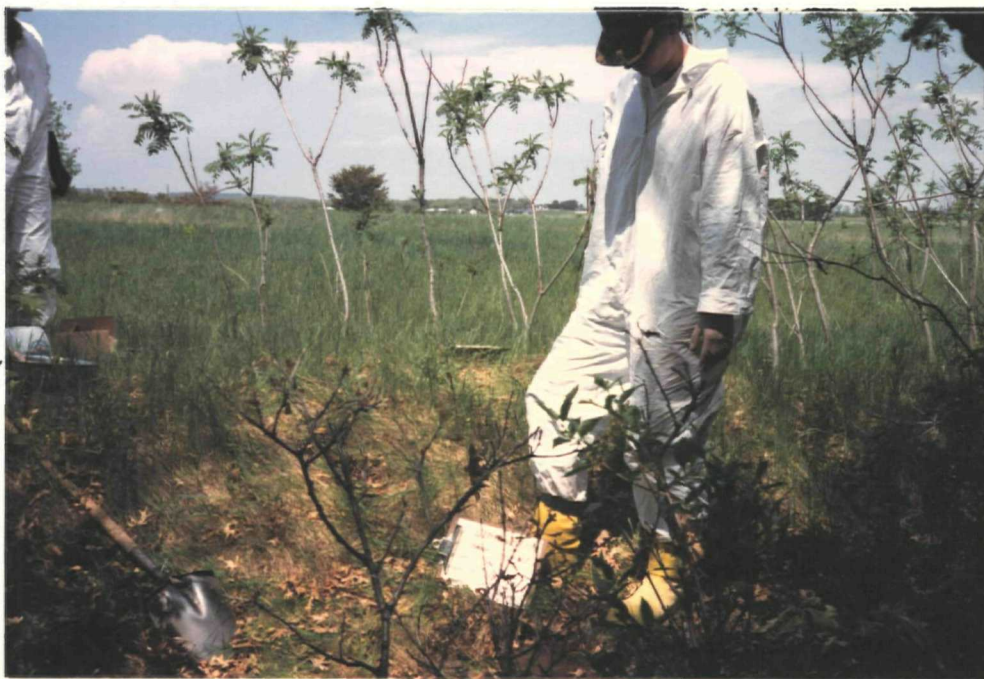
The TAL analytes lead and zinc were detected in elevated concentrations in on-site soil sample S6. All other TCL compounds and TAL analytes detected in on-site soil samples were found to be present at concentrations similar to those of the background soil sample (S7) (see Table 4-1 for complete soil sample analysis results).

DESCRIPTION: Close up view of soil sample S6 collected
from the south side of the site.DATE: 5/23/89TIME: 1405DIRECTION OF
PHOTOGRAPH:
SWEATHER
CONDITIONS:
Mostly Sunny
Mid 70'sPHOTOGRAPHED BY:
T. NehrKornSAMPLE ID
(if applicable):
S6

DESCRIPTION: Perspective view of soil sample S6.

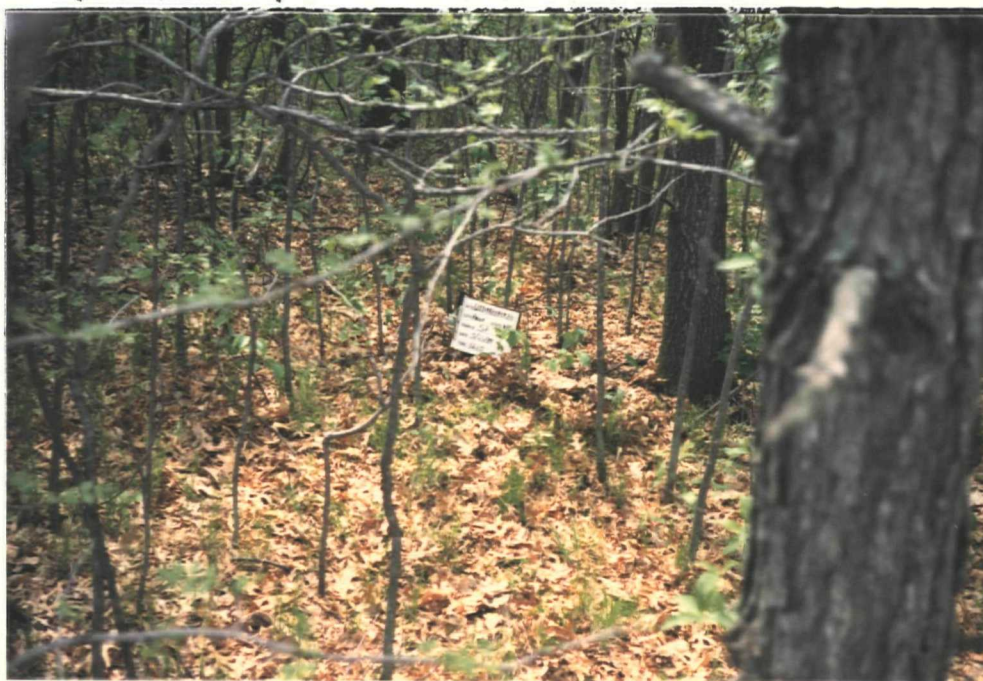
DESCRIPTION: Close up view of soil sample S7, a
potential background sample collected from a
wooded area approximately 1 mile north of the site.DATE: 5/23/89TIME: 1215DIRECTION OF
PHOTOGRAPH:SWEATHER
CONDITIONS:
Mostly SunnyMid 70'sPHOTOGRAPHED BY:
T. NehrKornSAMPLE ID
(if applicable):
S7

DESCRIPTION: Perspective view of soil sample S7.
